GEOTECHNICAL INVESTIGATION REPORT

# Coastal Development

**KIRI Pt Sec 88E  
TOKERAU TAPER  
ARORANGI DISTRICT  
RAROTONGA  
COOK ISLANDS**

## **GEOTECHNICAL INVESTIGATION FOR PROPOSED COASTAL DEVELOPMENT ARORANGI, RAROTONGA, COOK ISLANDS**

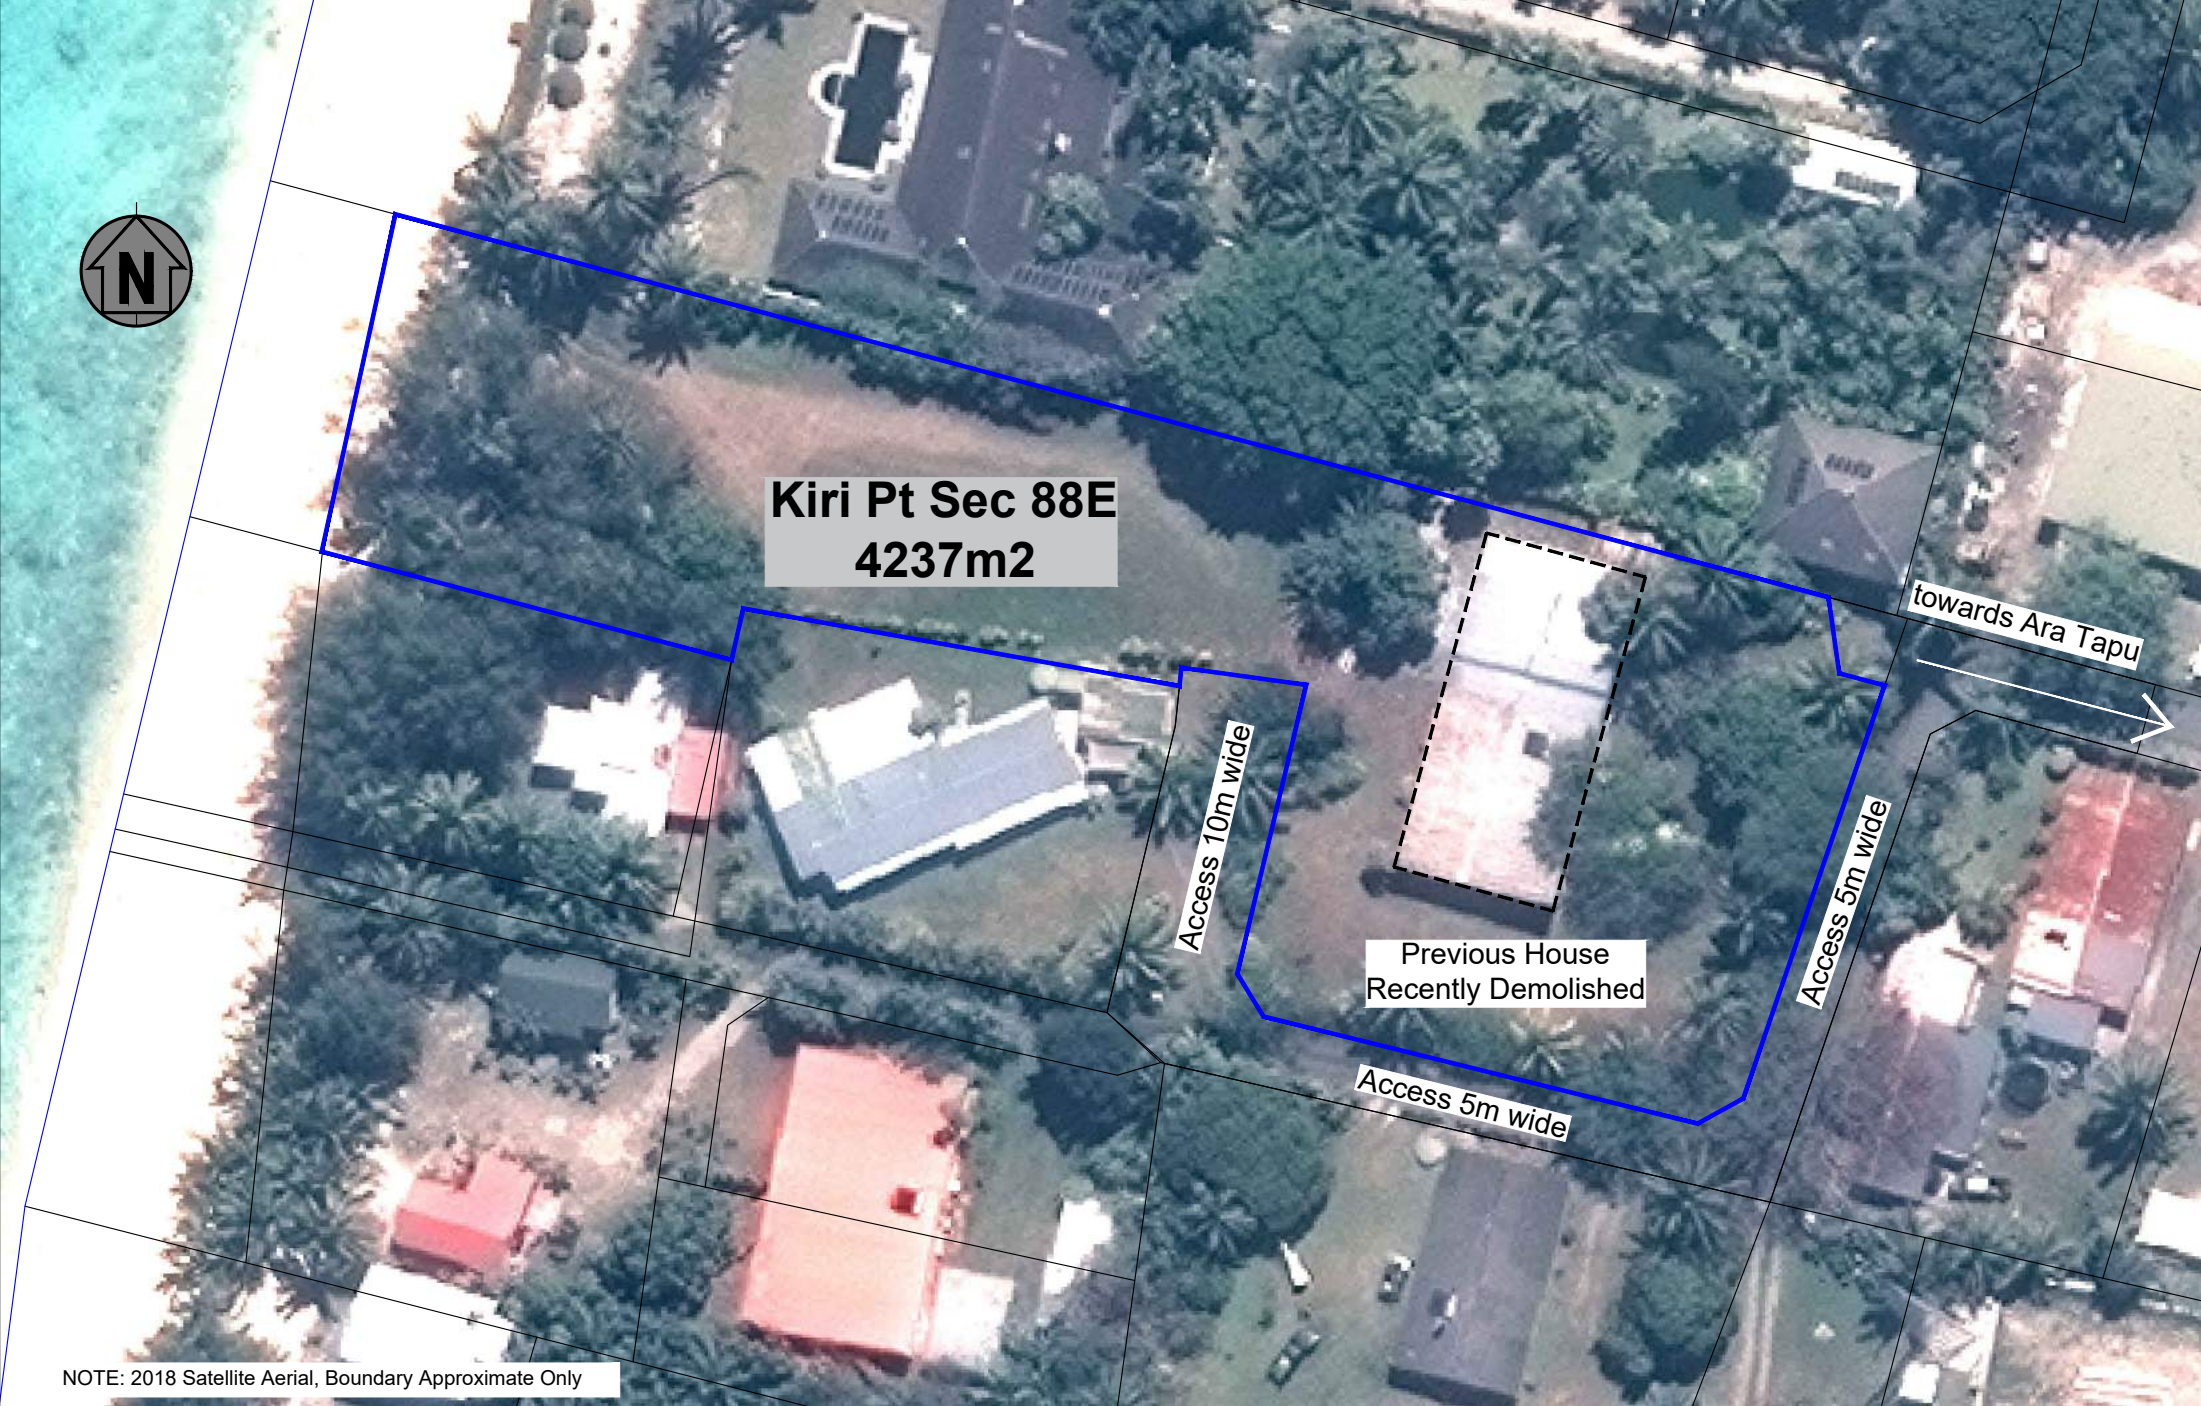
REVISION:	BY:	APPD:	DATE:	PROJECT TITLE:	DRAWING TITLE:	CLIENT: B.Baudinet	JOB REF: E2112	DATE	SHEET No.	Total No. of SHEETS:		
				Coastal Developement	Slte Plan - Property Boundary		DRAWN BY:	PZ	29/05/21	S01	S04	
						CAD REF:	E2112.dwg	CHECKED:				
						SCALE:	N.T.S.	APPROVED:

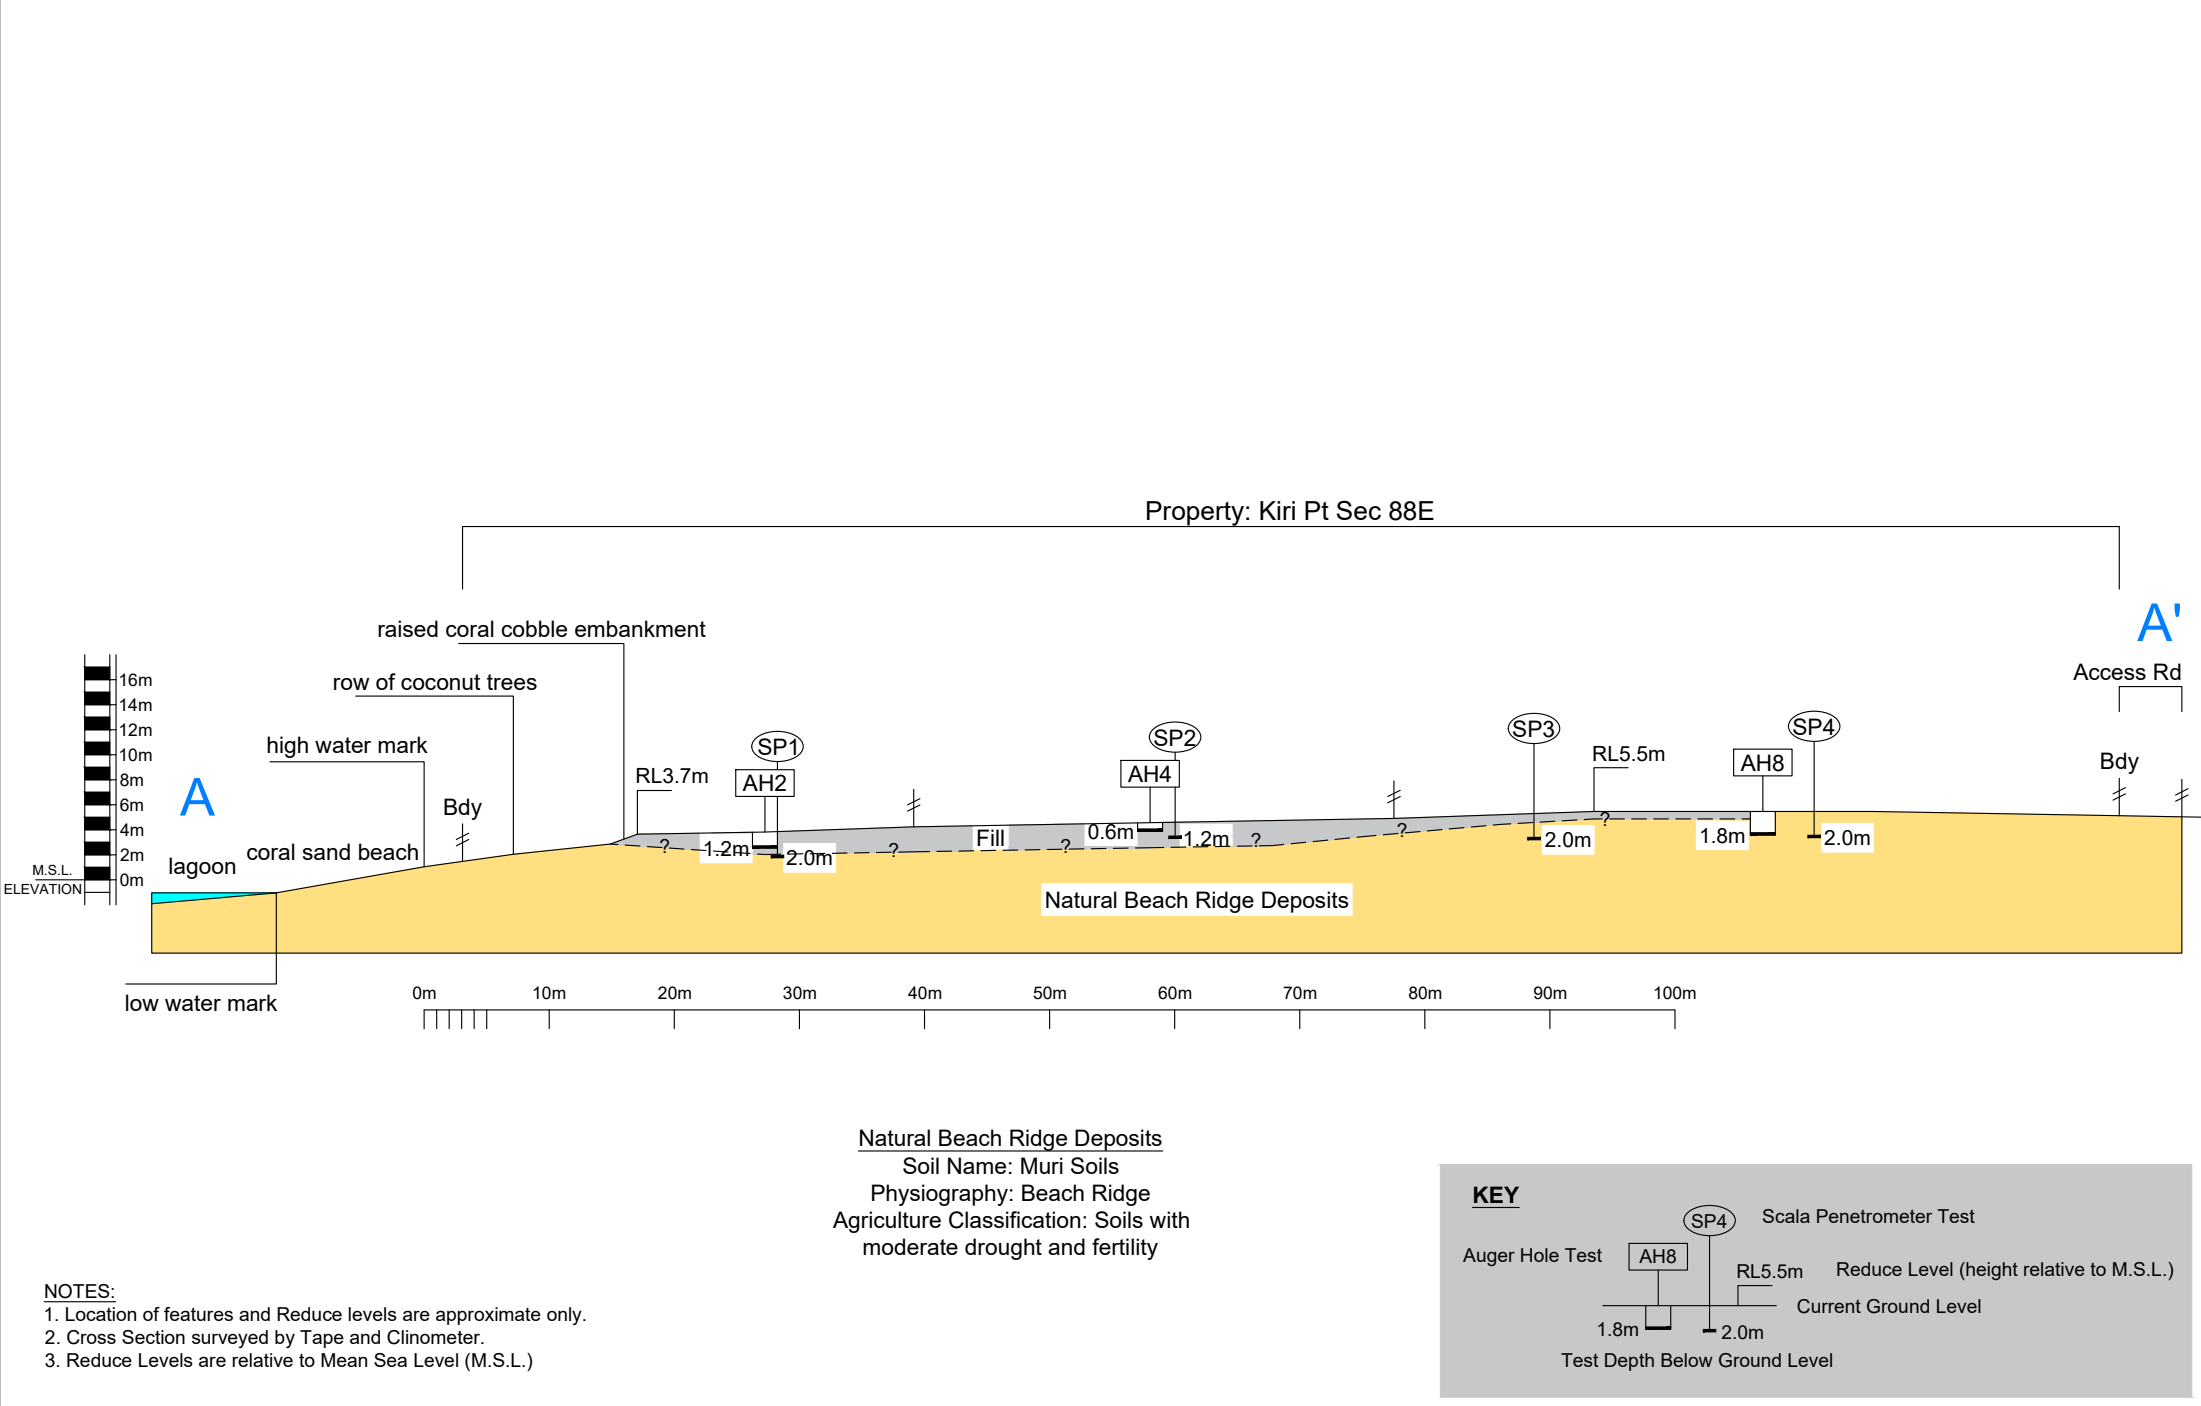
REVISION:	BY:	APP'D:	DATE:	PROJECT TITLE:	DRAWING TITLE:	CLIENT:	JOB REF:	DATE	SHEET No.	Total No. of SHEETS:
				Coastal Development	Cross Section Profile	B.Baudinet	E2112		S04	S04
							DRAWN BY:	PZ		
						CAD REF:	E2112.dwg	CHECKED:		
						SCALE:	N.T.S.	APPROVED:
